Number	N.4
Section	Body and Exhaust System
Sheet	1 (of 1)
Date	May, 1960

Number N.6
Section Body & Exhaust System

Number N.7
Section Body

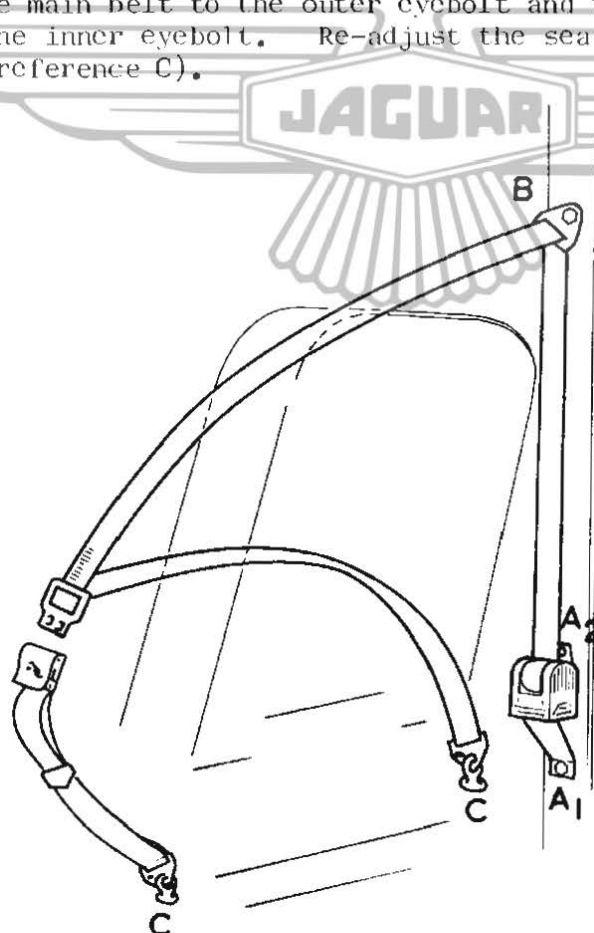
FIG.1 THE SEAT BELT FITTED

- (13) Attach the main belt to the outer eyebolt and the short (buckle) belt to the inner eyebolt. Re-adjust the seat position. (Fig. 1, reference C).

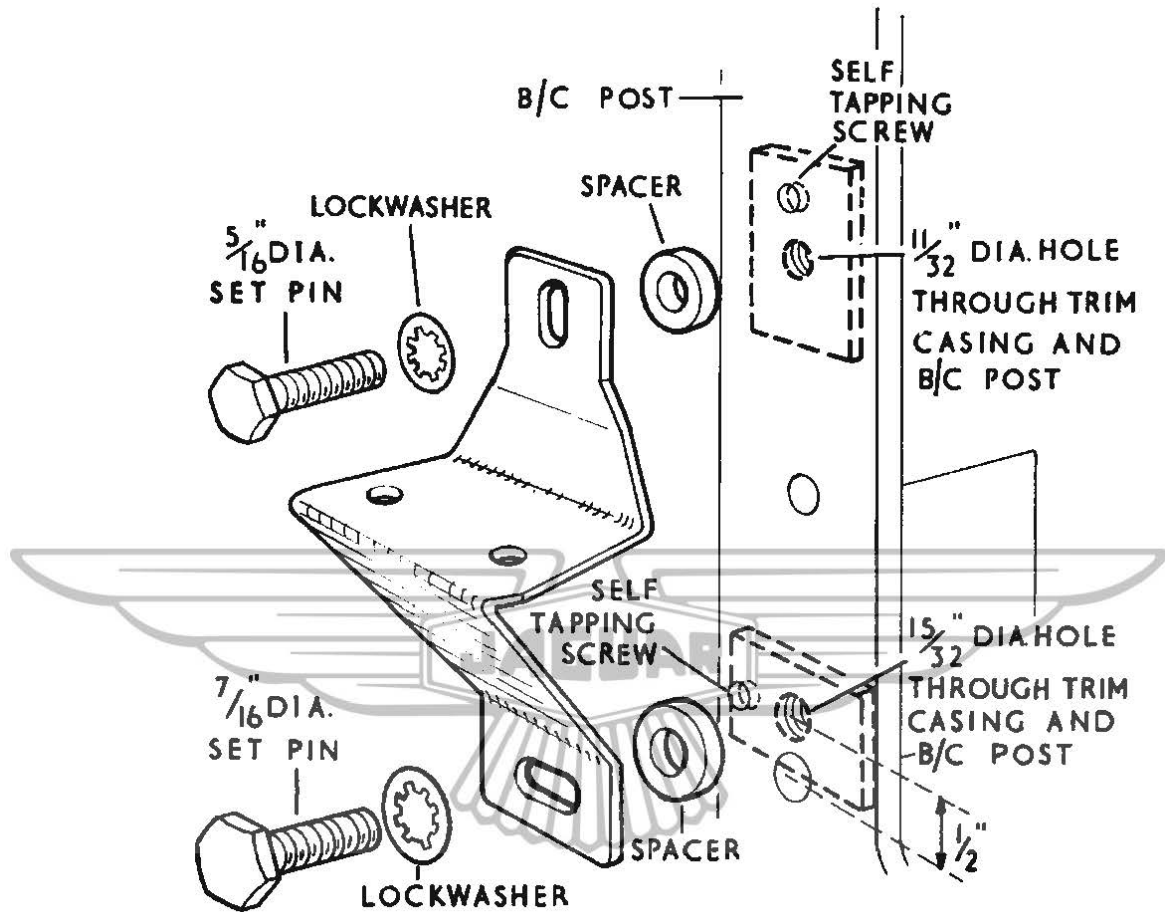
FIG.2 MOUNTING POINTS A₁ & A₂

- (9) Attach the reel to the bracket with the two 5/16" setscrews, nuts and lockwashers. Note that the unit must be fitted so that the strap unreels against the back of the bracket. Attach the mounting bracket to the 'B/C' Post with the 5/16" and 7/16" setscrews, plain and lockwashers; the two distance pieces supplied in the kit should be interposed between the bracket and the trimming (Fig. 2). Tighten the setscrews fully.
